**BURNED-AREA REPORT**  
(Reference FSH 2509.13)**PART I - TYPE OF REQUEST**

- A. Fire Name: Cascade Creek Fire      B. Fire Number: WA-GPF-000563  
C. State: Washington      D. County: Skamania (started), Yakima  
E. Region: 06      F. Forest: Gifford Pinchot National Forest  
G. District: Mt. Adams RD      H. Fire Incident Job Code: P6G7ZP  
I. Date Fire Started: 9/9/12      J. Date Fire Contained: 85% 10/15/2012 – rain/snow on 10/16 onward.  
K. Suppression Cost: estimated \$15,000,000 as of 10/24/12.

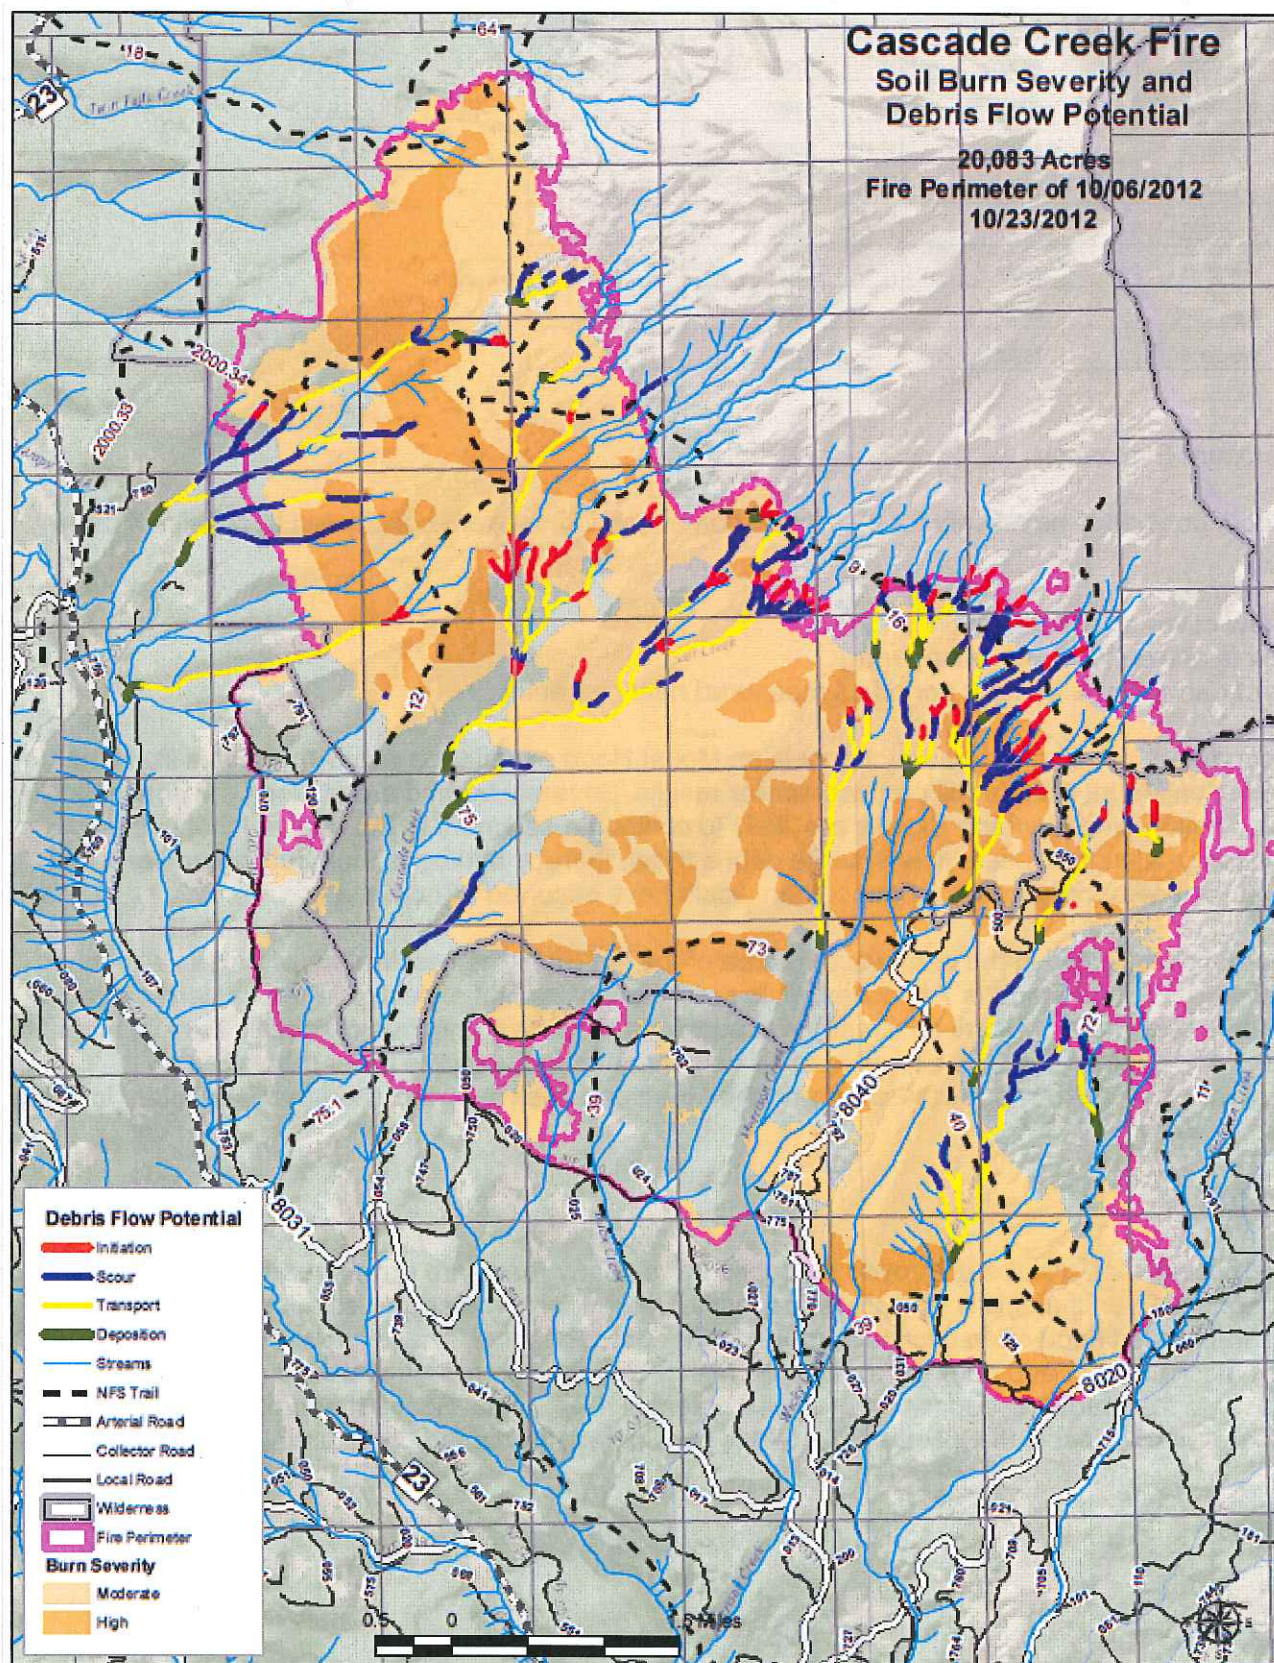
Map 1. Debris flow risk map.

Any decrease in root strength on a hillslope will increase the susceptibility of that hillslope to shallow landslides. Map 1 shows the areas within the Cascade Creek Fire perimeter where high burn intensity occurred on steep slopes, conservatively defined here as about 50%. These are the hillslope areas where small shallow landslides (debris slides) are most likely to occur at a higher frequency than pre-fire levels. This elevated hazard could continue for 15 years, or until vegetation is reestablished on these hillslopes.

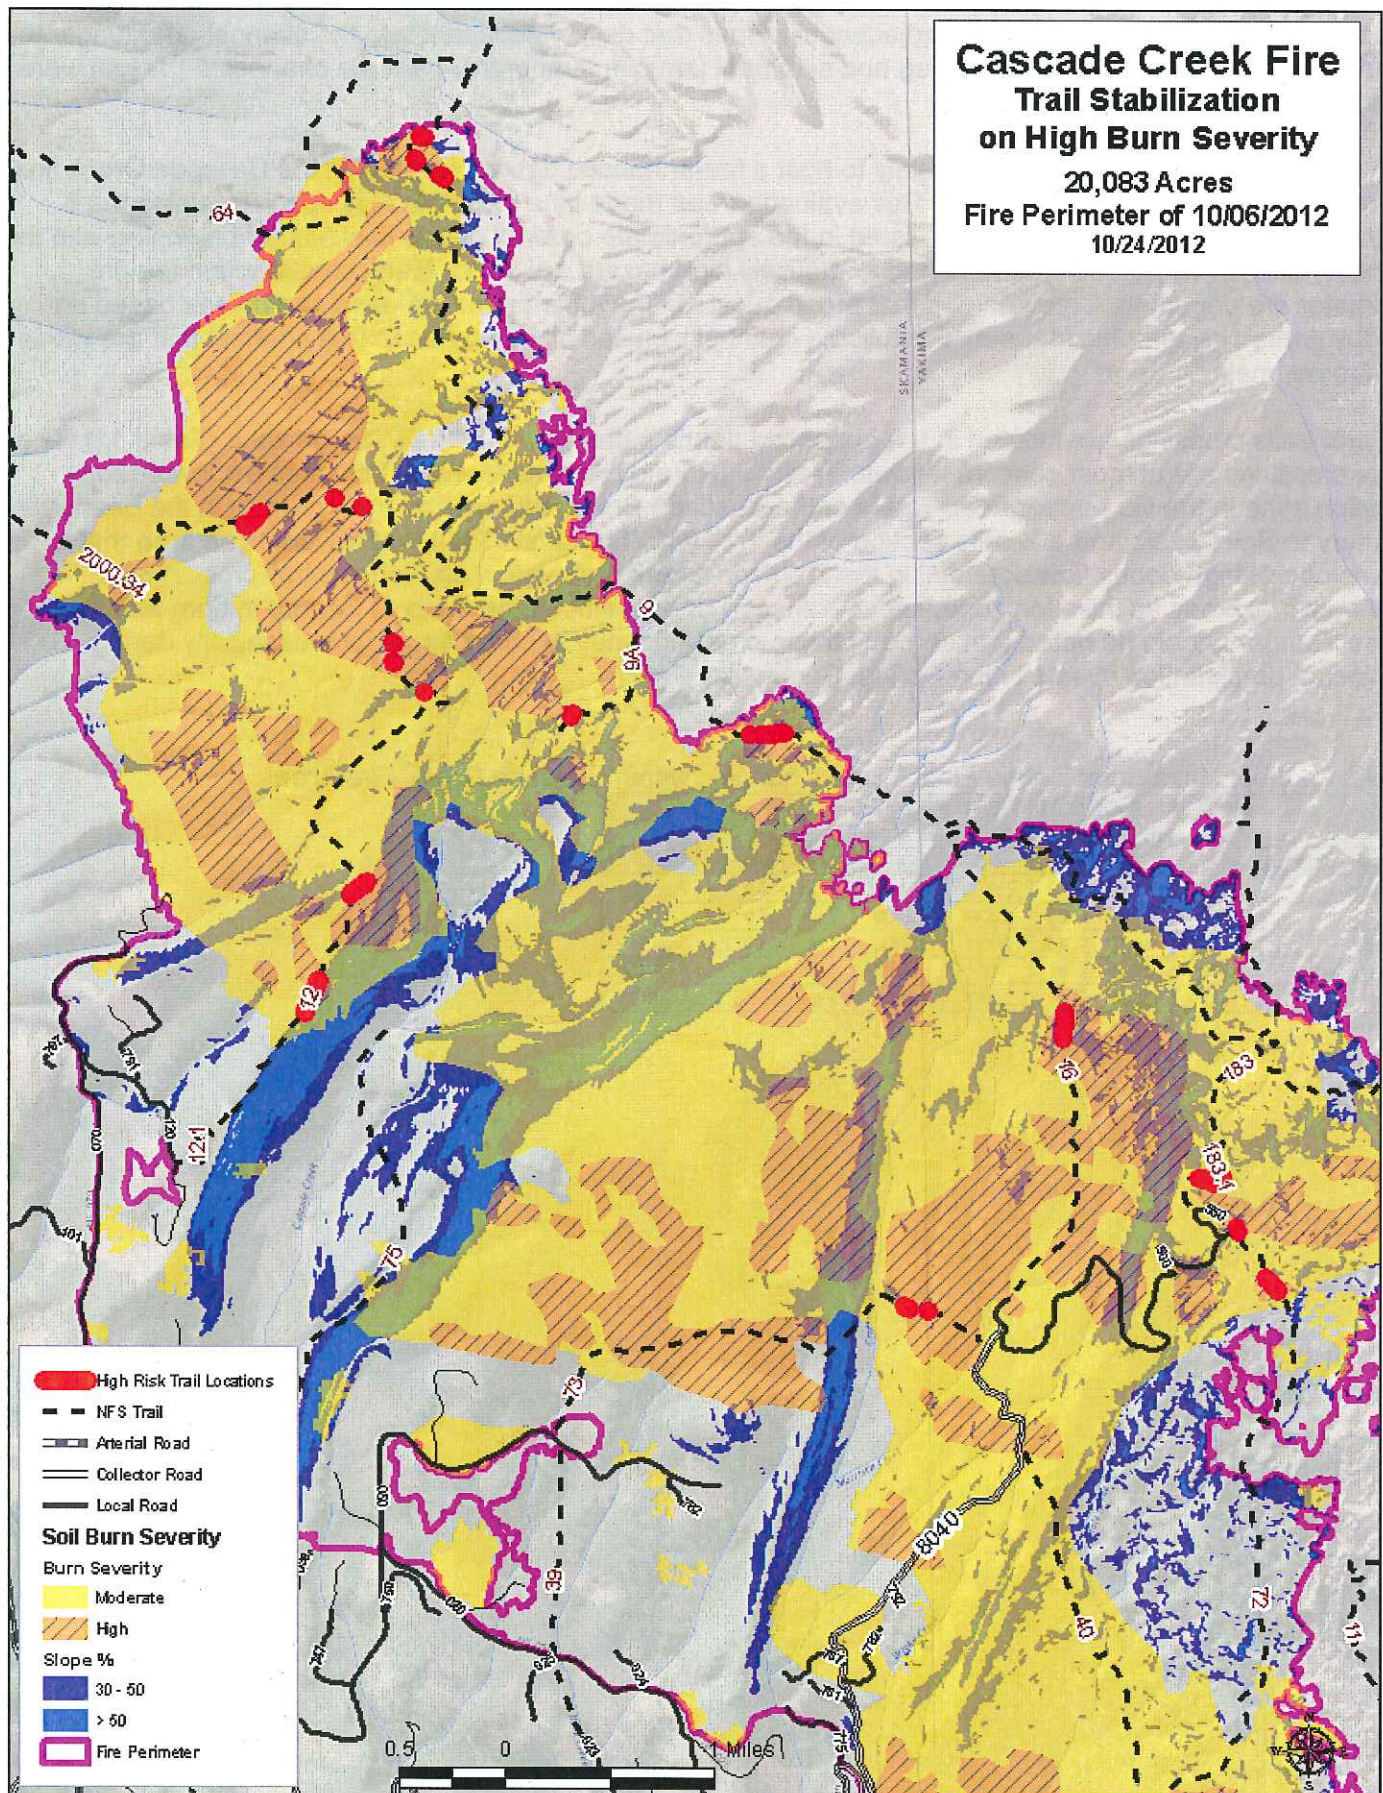
Map 2. Trails in high intensity burn areas with slope greater than 30% candidate for trail erosion stabilization.

Trail sections at highest risk are those located below steep slopes (>30%) in high intensity burn areas. Rill erosion, sheeting and some slough of materials are expected in many areas of the trails. Many trails are classified in the 12 to 20% gradient class and so include drainage structures. Trails were identified in high impact areas that would require immediate treatment to minimize erosion (Table 10; and Map 2).

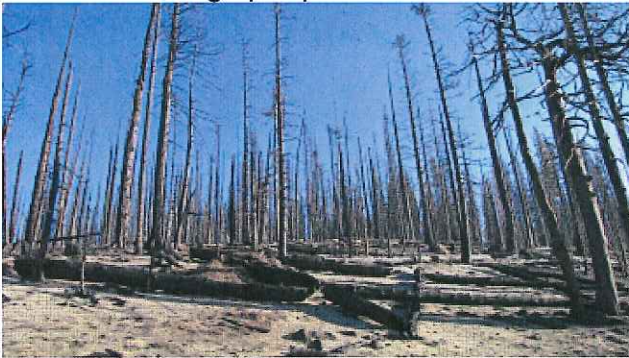
A nine hundred foot section of the 8040500 road (MP 1.0 to 1.2) and a 600 ft section (MP 2.6 to 2.8), and the 8040020 road crossing (Hole in the Ground Creek) are roads with the greatest concerns for damage to road prism and risk to life and property. There are no drainage structure on this road. The 8040020 road crossing over Hole in the Ground Creek would most likely be affected from excess flooding and debris blockage at the culvert inlet increasing the likelihood of flow restriction causing stream levels to rise and overtop the road. The Hole in the Ground Creek crossing is located at the fire perimeter's edge. It is the only crossing that is closest to the fire with a high intensity burn area located only  $\frac{3}{4}$  mile upstream.

Photo 1. Looking upslope above 8040500 road at MP 1.1. Prior to receiving rainfall.

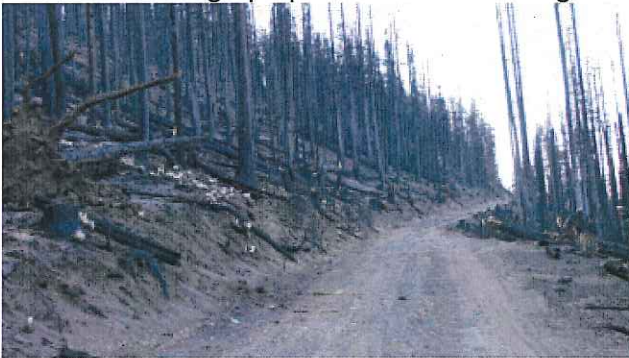
Photo 2. Looking up up 8040500 road in high burn area at MP 1.0 after receiving moderate rainfall.

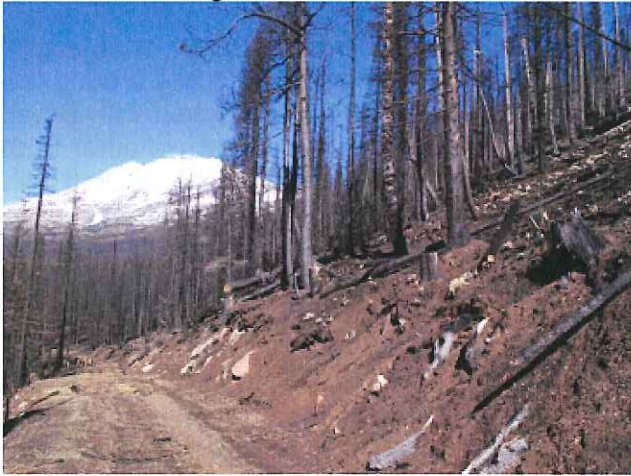
Photo 3. Looking down 8040500 road at MP 1.1 after receiving moderate rainfall.

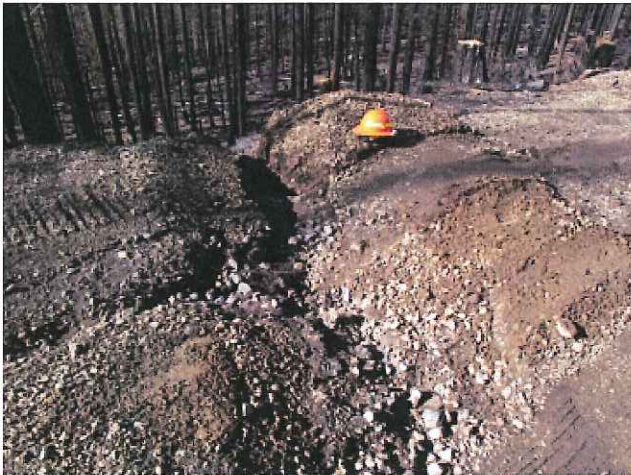
Photo 4. Erosion at waterbar on 8040500 road at MP ~1.1 after receiving moderate rainfall.

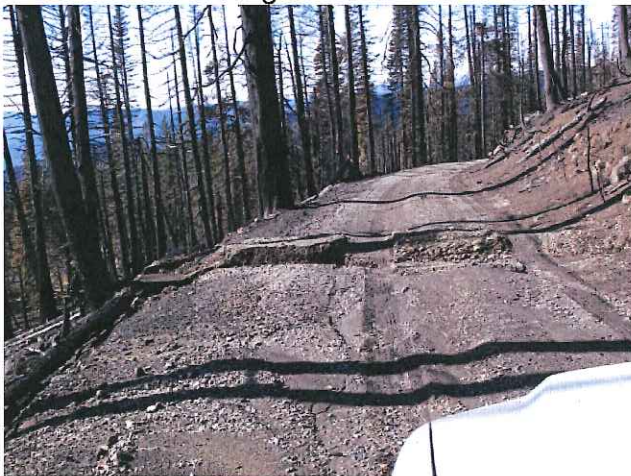
Photo 5. MP Looking down 8040500 road at MP 2.7 after receiving moderate rainfall.
