# The effects of log erosion barriers on post-fire hydrologic response and sediment yield in small forested watersheds, southern California

Peter M. Wohlgeomuth,<sup>1\*</sup> Ken R. Hubbert<sup>1</sup> and Peter R. Robichaud<sup>2</sup>

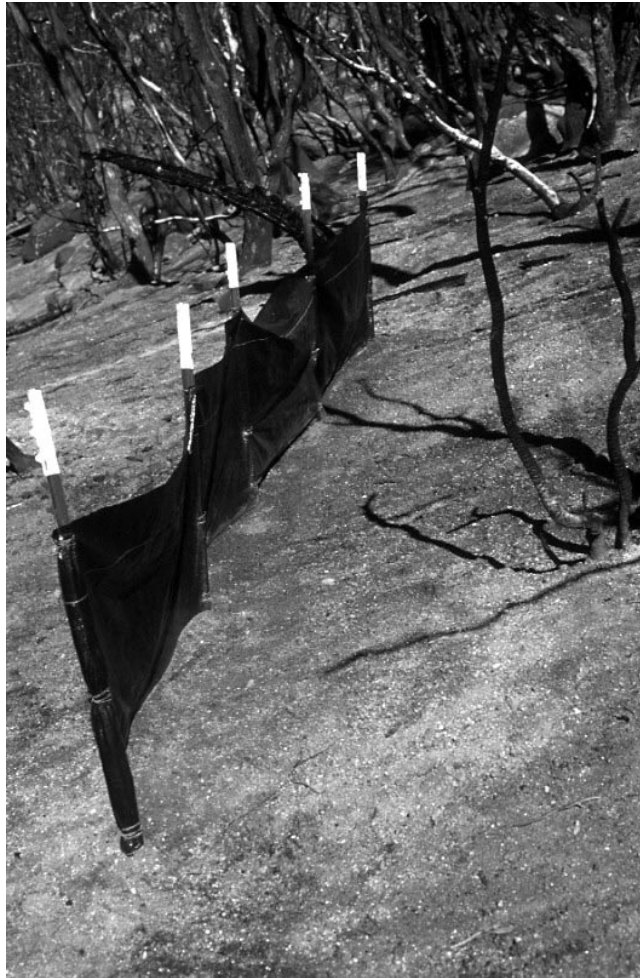
Figure 2. Photograph of a silt fence to measure surface erosion

We measured hillslope erosion in the Mixing Fire study area with silt fence barriers (Robichaud *et al.*, 2000). These barriers, constructed of silt cloth wired to t-posts (see Figure 2), retained sediment from plots that ranged from 3.7 to 4.3 m wide by 12 to 30 m long. The average contributing area for each silt fence was 83.6 m<sup>2</sup>. We sprinkled construction chalk just uphill of the barriers to identify the initial ground surface, then removed and measured the captured material as it accumulated. Twenty silt fences were installed in the project area outside of the study watershed boundaries (Figure 1).

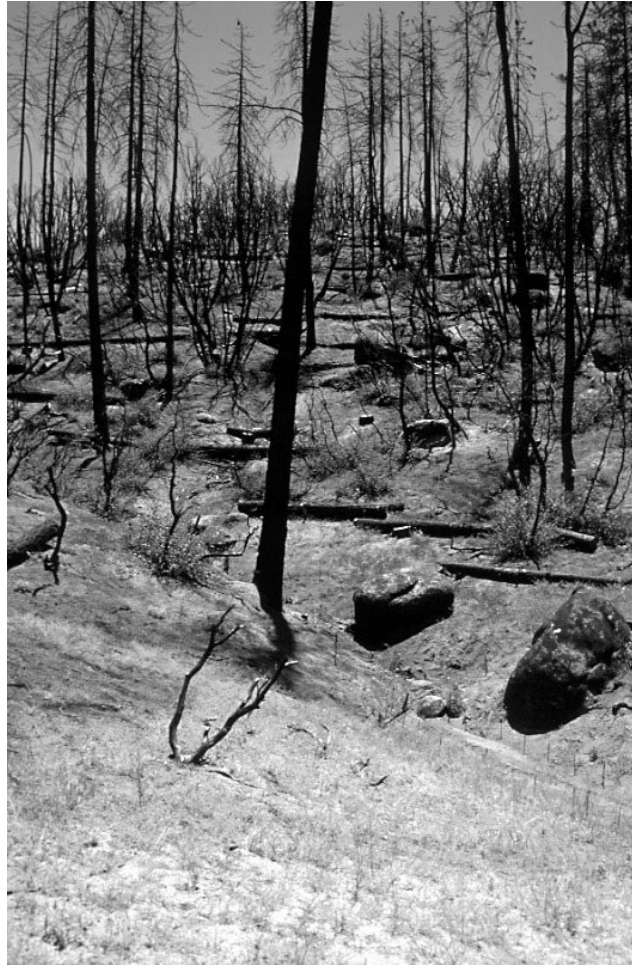
Figure 3. Photograph of Watershed B showing the LEBs

We initially inventoried the LEBs in the Mixing Fire study area to determine the number, size and spacing, and estimated storage capacity (see Figure 3). We inspected the LEBs periodically for sediment accumulation and leakage. Sediment accumulation was determined by ocular estimate compared with initial capacity assessments, but, unlike the silt fences, we never removed the sediment.

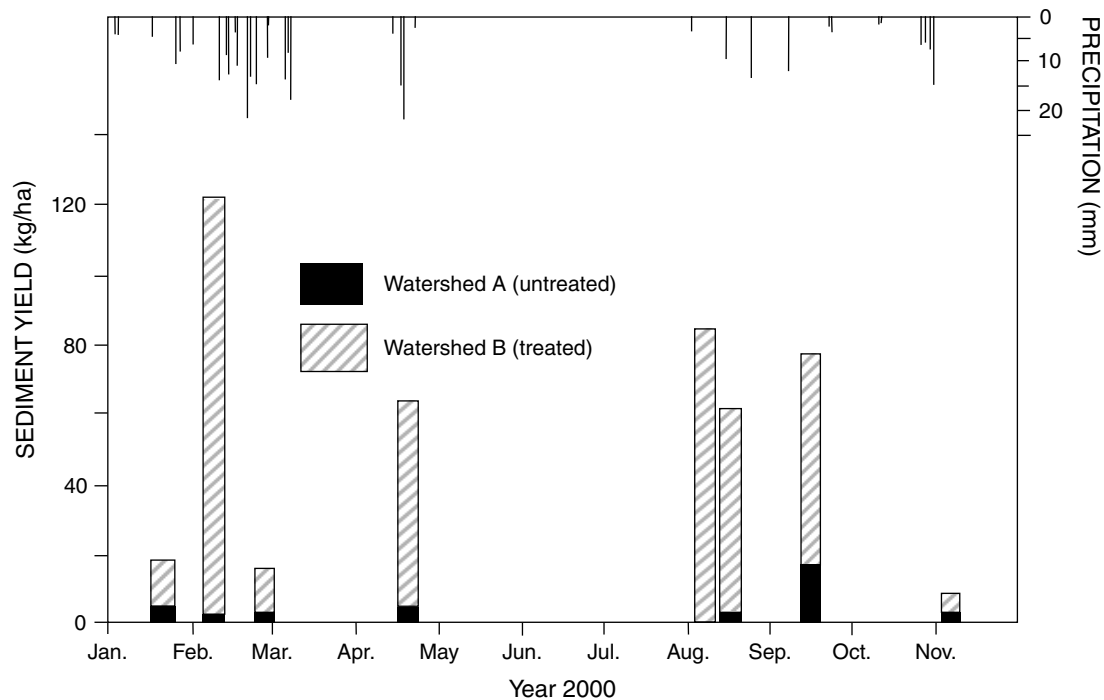
Figure 4. Sediment yields measured throughout the year for Watershed A (untreated) and Watershed B (treated) in relation to recorded precipitation events

Sediment yield is the integrated output of sediment from a watershed unit. Sediment is stripped off the hillslopes, scoured out of the channels, and transported to the watershed outlet. Sediment yield reflects the complicated balance of rainfall amounts and intensities, hillslope erosion, and channel scour and fill. One significant finding of this project is the great disparity in sediment yield between the two study watersheds. Rain-derived streamflow is the only mechanism by which sediment can be delivered to the debris basins. Unfortunately, there is no simple relationship between either rainfall totals or intensities that appears to govern sediment yield (see Table VI). Over half the total sediment yield in Watershed A was the result of a single thunderstorm on September 7, 2000, with total depth and peak intensity that were singularly un spectacular (Figure 4).
