Hayman Fire Case Study Analysis:

Postfire Rehabilitation

Pete Robichaud, L. MacDonald, J. Freeouf, Dan Neary, D. Martin

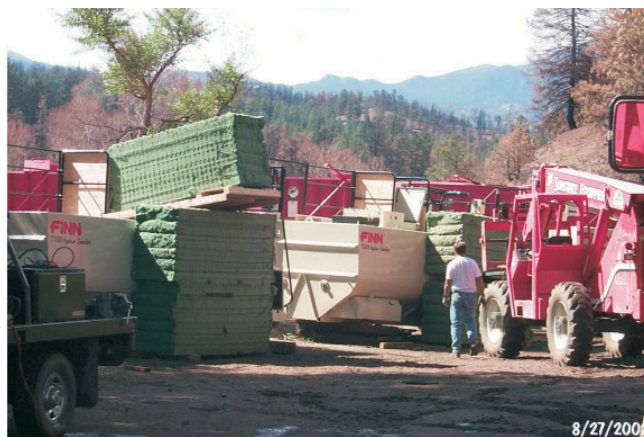
Figure 7—Hydromulch staging area.

- *Aerial hydromulching with seed (fig. 7, 8, 9)*: For 1,500 acres (610 ha). For the high severity burn areas draining to the South Platte River below Cheesman dam, which cannot be reached by existing roads, aerial hydromulching will occur. The intent of the treatment is to prevent loss of topsoil, improve infiltration rates and replace organic litter consumed by the fire. The focus will be on ridge-tops and upper one-third slope positions with slopes of 20 to 60 percent. Application rate will be 2000 lb per acre (2.24 Mg per ha), and the mulch and tackifier to be used by the contractor will be suitable for 20 to 60 percent slopes. Seed will be included in the mix as described in table 8.

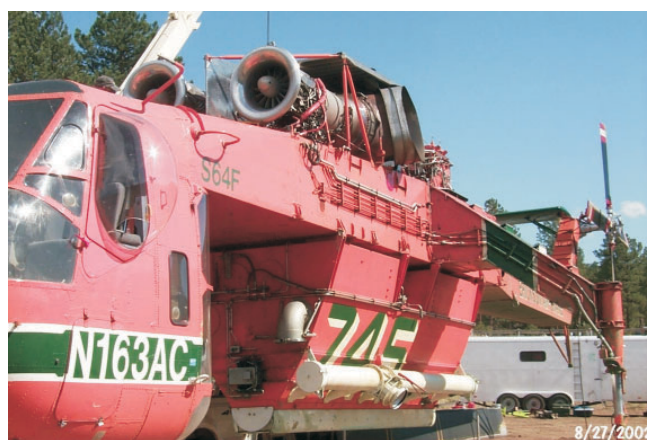
Figure 8—Helicopter with tanks for hydromulch slurry.

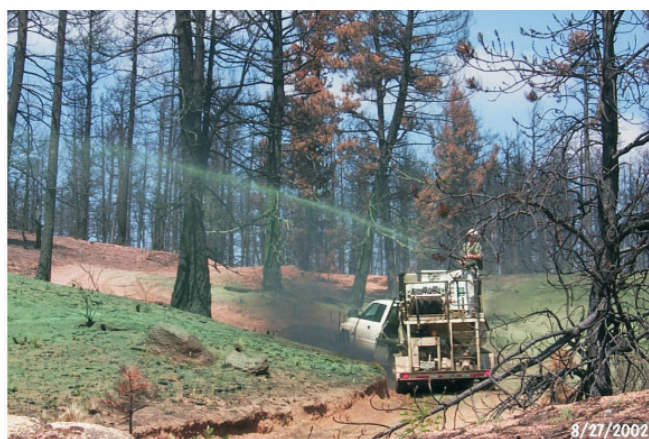
Figure 6—Ground-based application of hydromulch with seed.

- *Ground-based hydromulching with seed (fig. 6)*: For 1,500 acres (607 ha). From existing roads and high severity burn areas that can be reached by existing roads, truck-mounted hydromulching will occur for an area within 300 feet (91 m) either side of the road. Ground cover amounts will be 2,000 lb per acre (2.24 Mg per ha), and seed will be included in the mix as described in table 8.

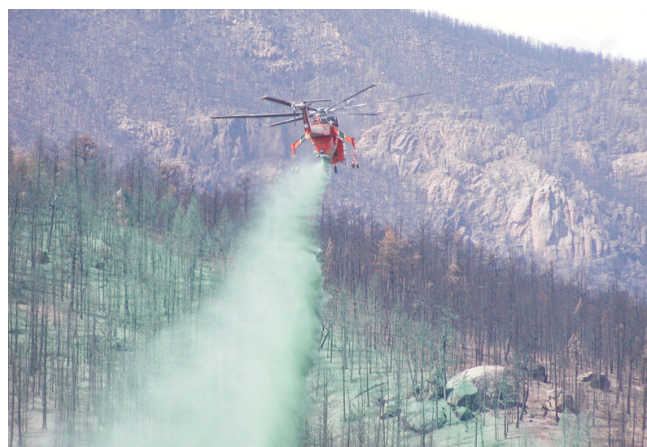
Figure 9—Aerial application of hydromulch with seed

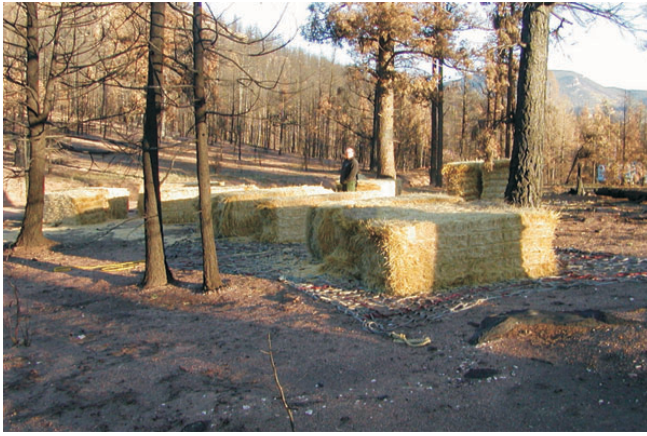
Figure 10—Aerial dry mulch staging area. Straw bales on cargo nets ready for helicopter transport.

above Cheesman dam that cannot be reached by existing roads, dry mulching will occur. The intent of the treatment is to prevent loss of topsoil, improve infiltration rates and replace organic litter consumed by the fire. Focus will be on ridge-tops and upper one-third of the slopes. Application rate will be 2000 lb per acre (2.24 Mg per ha), and the mulch used by the contractor will be suitable for 20 to 60 percent slopes. Seed will be included in the mix as described in table 8.

Mulch can be applied most easily where road access is available because bales must be trucked in, although they can be transported and distributed by helicopter. The use of helicopters to spread mulch is relatively new in postfire emergency rehabilitation. Effectiveness of mulch depends on even application and consistent thickness. Recent effectiveness monitoring on the Bobcat Fire in the northern Colorado Front Range showed that dry mulch, seeding, and contour log erosion barriers did not significantly reduce sediment yields in the first summer after burning. This lack of effectiveness can be attributed to the intense rain event that overwhelmed all the treatment efforts. In the second year after burning, rainfall was spread over several smaller events, and the sediment yields in the both the mulched and contour-log erosion barrier areas were significantly less than the sediment yields in untreated areas. Although mulching was somewhat more effective than contour-log erosion barriers, seeding had no significant effect on sediment yields at the hillslope scale (Wagenbrenner and others 2002).

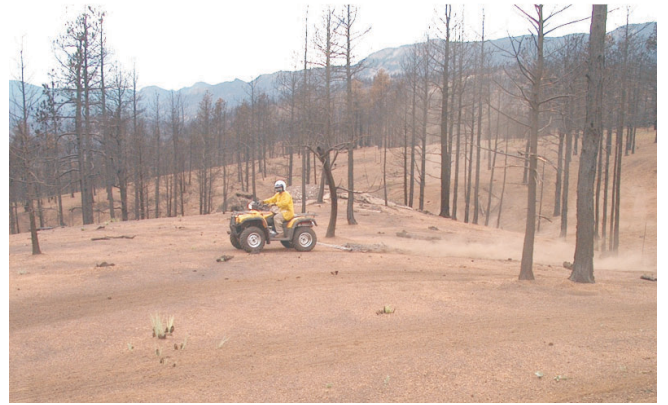
Figure 12—Mechanical scarification with all terrain vehicle.

high severity-burn areas on slopes less than 20 percent that pose a threat to downslope values and onsite soil erosion. Areas will be treated with a chain link harrow with 4 inches (10 cm) teeth pulled behind an all terrain vehicle on the contour and seeded with the mix as described in table 8. The harrow will also break up the water repellent soil layer and increase infiltration.

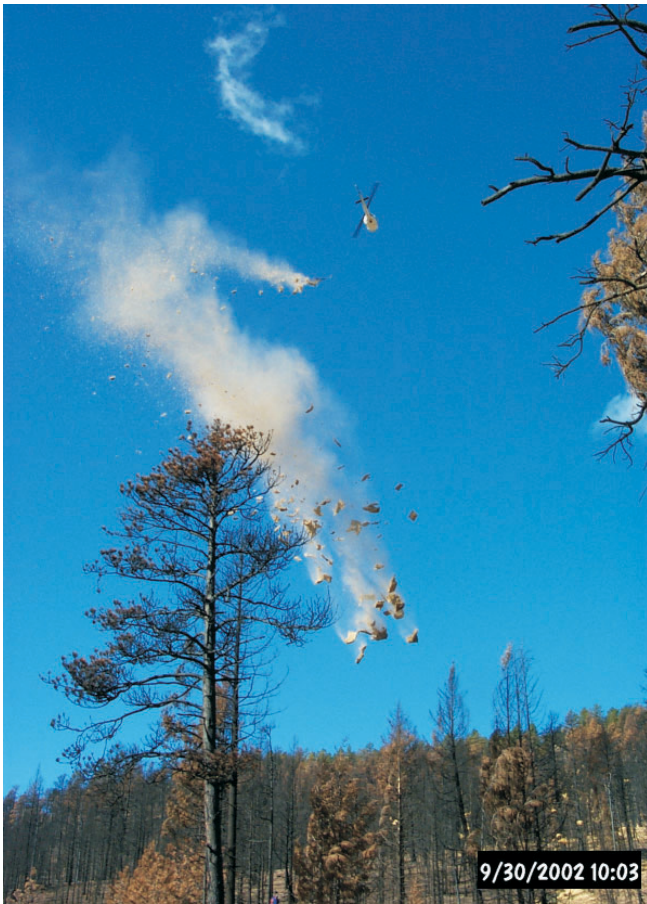
Figure 11—Aerial dry mulch being applied.

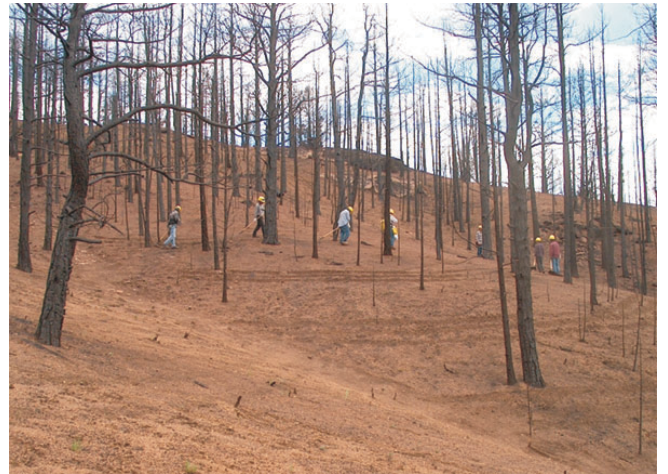
Figure 13—Hand scarification with volunteers from *Colorado Cares* event.

Scarification—Scarification is a mechanical soil treatment aimed at improving infiltration rates in water repellent soils. Scarification may increase the macro porosity of the soil and physically break up the water repellent layer, thus increasing the amount of rainfall that infiltrates into the soil. Hand tools (McClouds) are commonly used in inaccessible or steep terrain, whereas all-terrain vehicles (ATV) and tractors have been used on gentle slopes to drag a harrow behind to break up the water repellent soil layers. Depths of the hand tools are generally shallow (0.5 to 1.5 inches, 1.3 to 3.8 cm) whereas machine pulled harrows or rippers can be 1 to 12 inches (2.5 to 30 cm) deep.

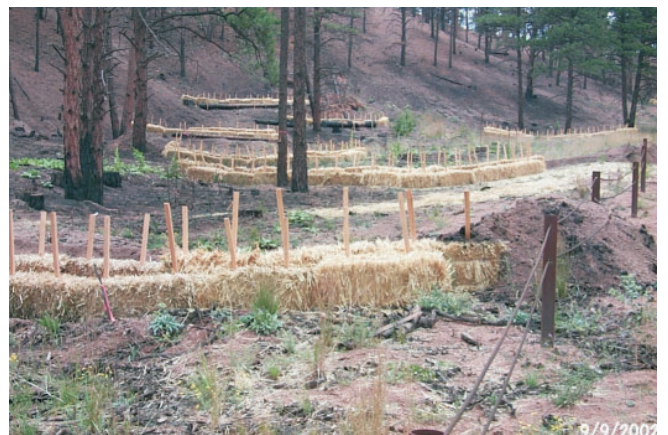
Figure 14—Strawbale check dams located on Denver Water Board property within the Hayman Fire area.

- **Channel treatments (fig. 14):** The BAER Team recommended no channel treatments. However, the Denver Water Board is using strawbale check dams in tributaries above Cheesman Reservoir. Therefore, a discussion of their effectiveness is presented in section three.
