*An ASABE Meeting Presentation*

*Paper Number: 068009*

## **Protection from Erosion Following Wildfire**

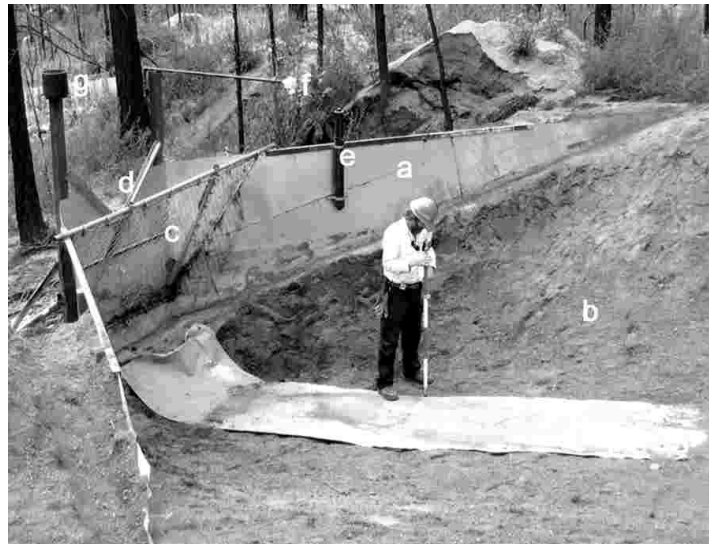
Figure 1. Typical paired catchment sediment basin after removal of sediment. a) sheet metal barrier wall; b) sediment basin area; c) debris collection rack; d) V-notch weir; e) magnetic/electronic stage sensor; f) ultrasonic depth sensor; g) tipping bucket rain gauge (Robichaud 2005).

*Paired catchments*—A paired catchment experiment measures runoff and sediment yield from natural rainfall in two adjacent catchments (2 to 10 ha with natural drainage to a single exit point) that are closely matched for size, slope, aspect, elevation, soil characteristics, and burn severity. One catchment has a postfire rehabilitation treatment applied and one is left untreated as a control. Runoff is measured using a 90 degree V-notch weir and sediment, which is collected in the impoundment basin, is removed, weighed, and sampled manually after each rain event. Rainfall intensity, amount, and duration are related to the measured runoff and sediment yield (fig. 1).

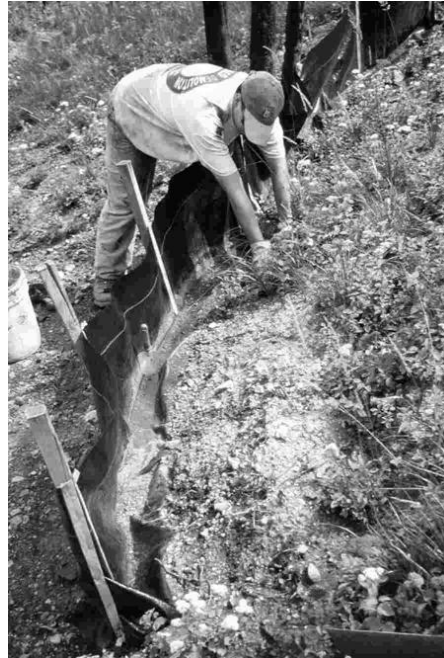
Figure 2. Typical sediment fence where accumulated sediment is being removed (Robichaud 2005).

*Sediment fences*—Sediment fences, constructed of silt fence fabric, provide a less expensive method to directly measure hillslope erosion (Robichaud and Brown 2002). Although runoff cannot be assessed, multiple fences allow for several replicates of each treatment. Sediment fences are best located on uniform slopes with minimal obstructions or in small swales (less than 0.5 ha in size). As with paired catchments, collected sediment is removed, weighed, and sampled manually after each storm event, and data from continuous-recording tipping-bucket rain gauges allow rainfall intensity, amount, and duration to be related to sediment yields (fig. 2).
