Measuring Hillslope Erosion with Silt Fences

Measuring hillslope erosion has historically been a costly, time-consuming practice. An easy to install low-cost technique using silt fences (geotextile fabric) and tipping bucket rain gauges to measure onsite hillslope erosion was developed and tested. Equipment requirements, installation procedures, statistical design, and analysis methods for measuring hillslope erosion are discussed. The use of silt fences is versatile; various plot sizes can be used to measure hillslope erosion in different settings and to determine effectiveness of various treatments or practices. Silt fences are installed by making a sediment trap facing upslope such that runoff cannot go around the ends of the silt fence. The silt fence is folded to form a pocket for the sediment to settle on and reduce the possibility of sediment undermining the silt fence. Cleaning out and weighing the accumulated sediment in the field can be accomplished with a portable hanging or platform scale at various time intervals depending on the necessary degree of detail in the measurement of erosion (that is, after every storm, quarterly, or seasonally). Silt fences combined with a

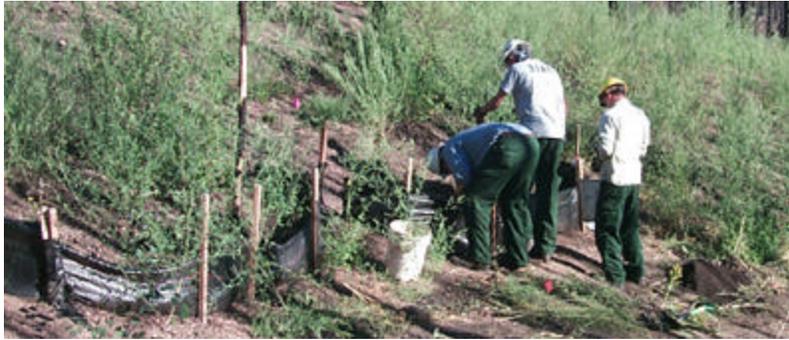
Cleaning out sediment first year, 2002 Hayman fire, Pike-San Isabel National Forest.

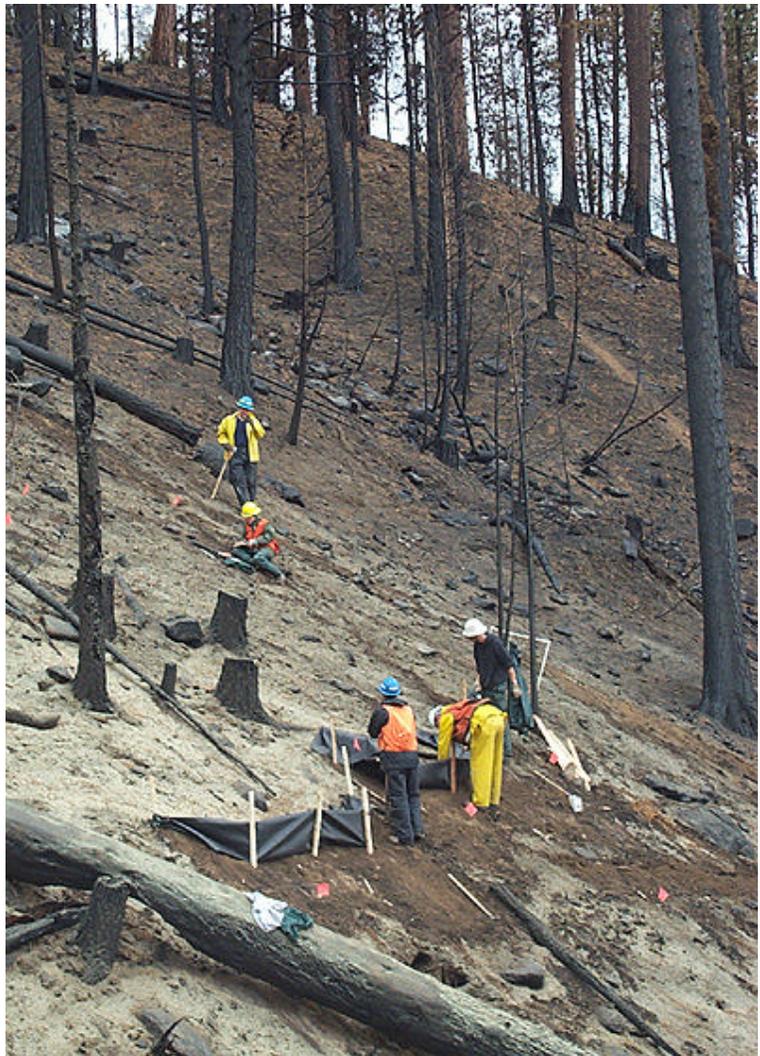
Installing silt fences to monitor the effectiveness of hydromulch after the 2003 Myrtle Creek fire, Idaho Panhandle National Forest.

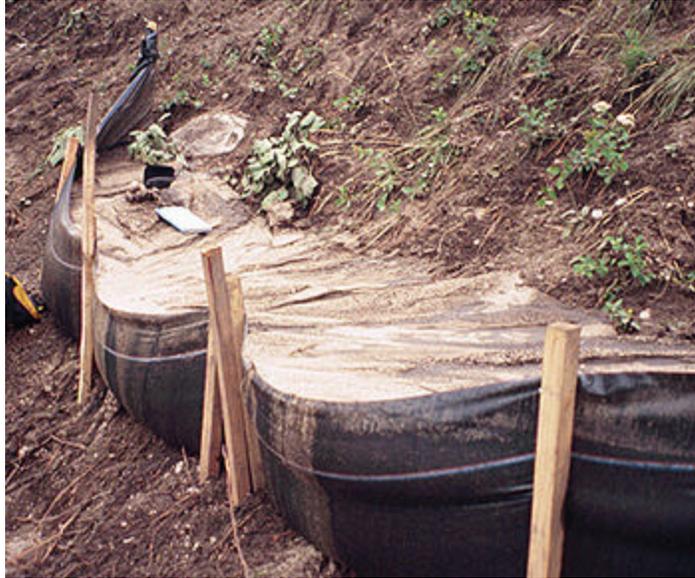
Full fence after the 2000 Bitterroot Valley fires.

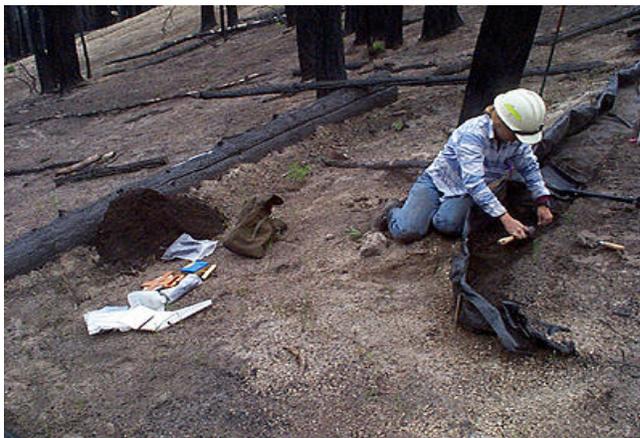
Cleaning sediment after the 1998 North-25 fire in the Wenatchee National forest.

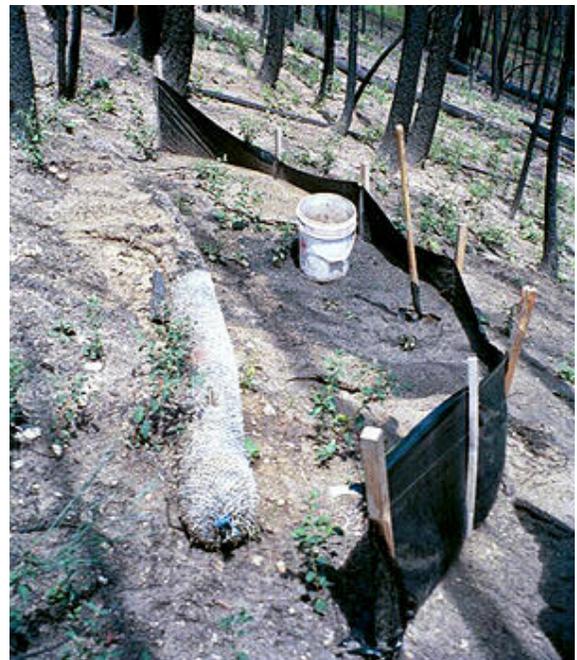
Comparing the effectiveness of a straw waffle after the 2000 Bitterroot Valley fires.

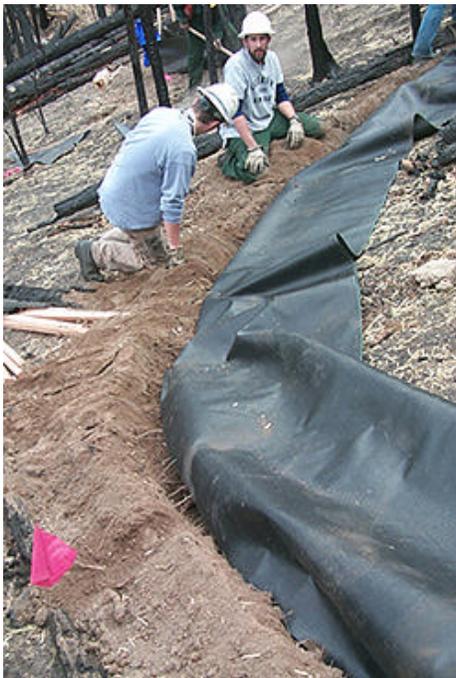
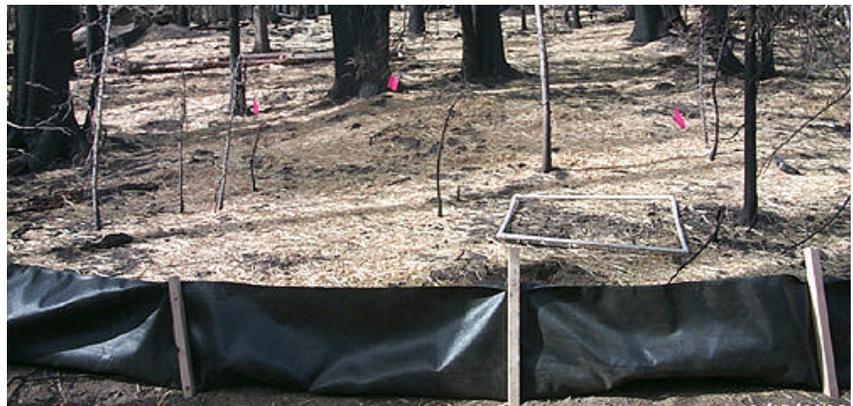
Silt fence installation and completion, after the 2003 Hot Creek fire, James Creek, Atlanta -- comparing to the effectiveness of straw mulch.
