California Forestry Report No. 7

February 2023

Mitigating Potential Sediment Delivery from Post-Fire Salvage Logging

Joe Wagenbrenner¹, Drew Coe², and Will Olsen³

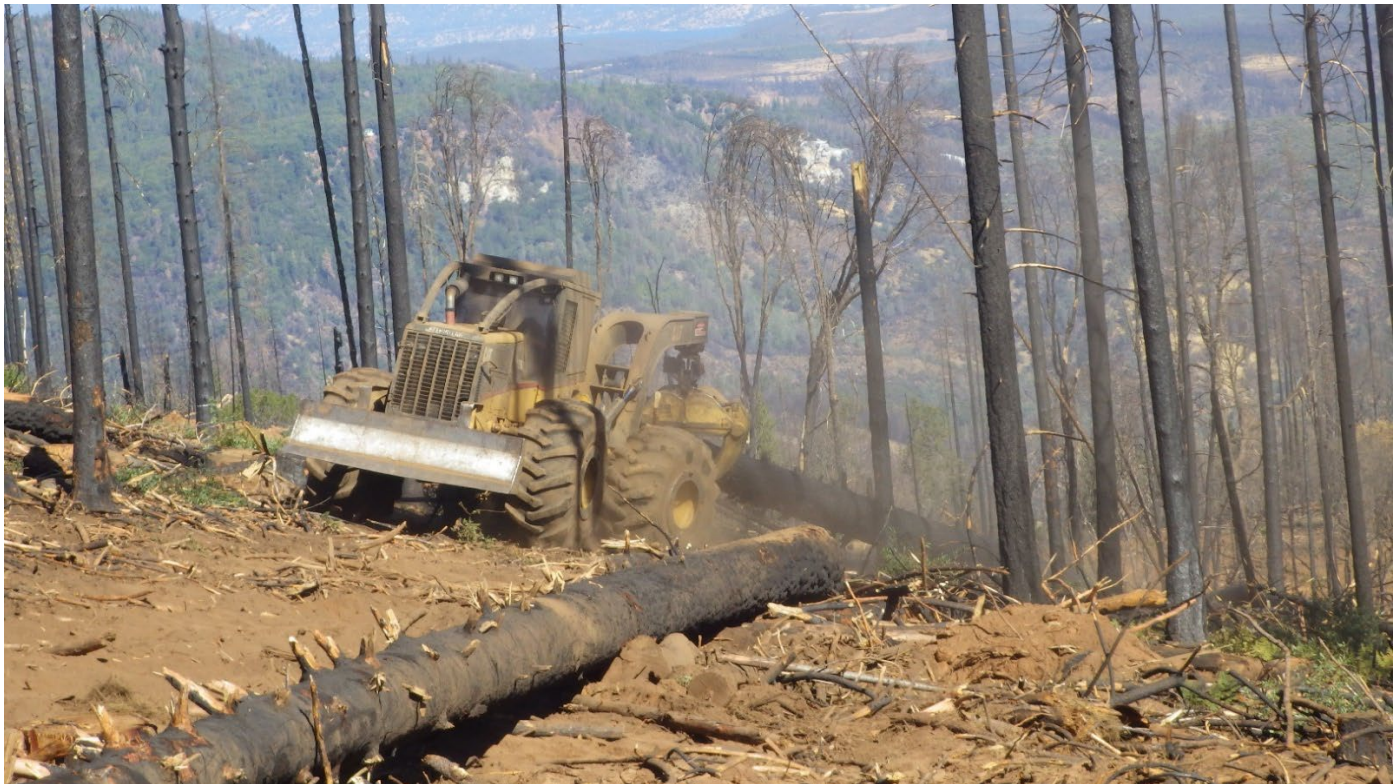
Rubber-tired skidder operating after the 2015 Valley Fire on the Boggs Mountain Demonstration State Forest in Lake County, California.

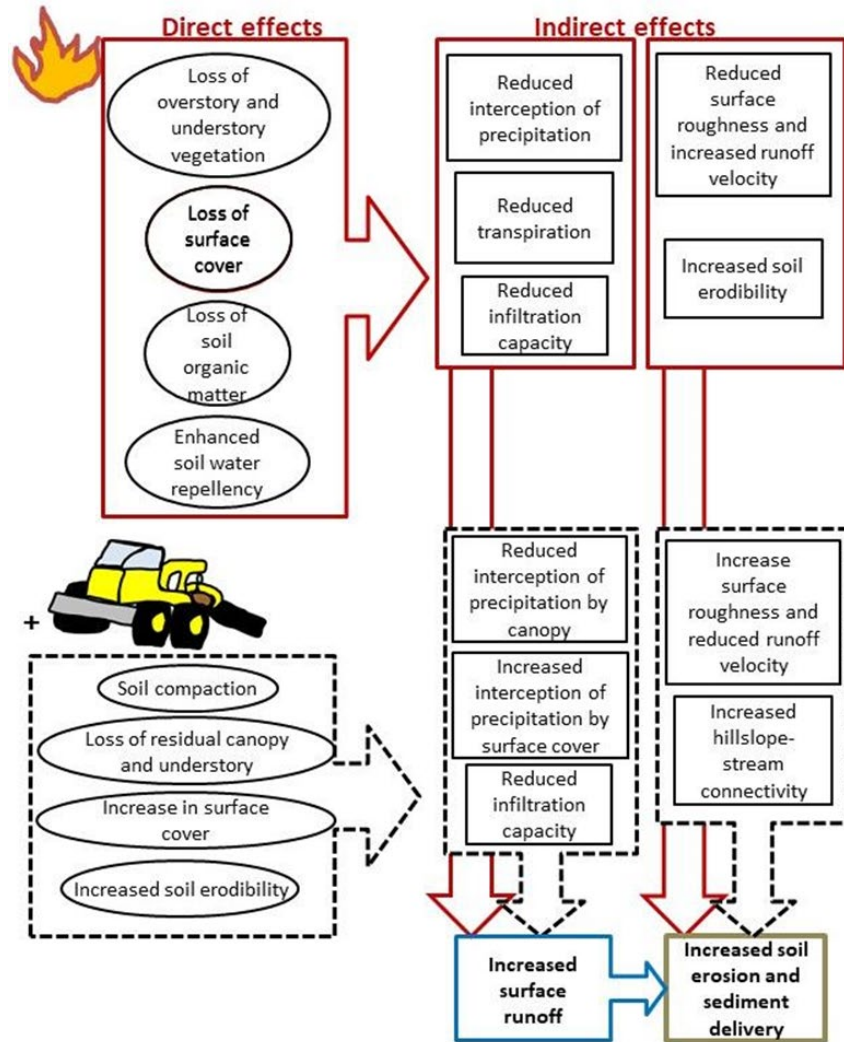
Figure 1. Some of the relevant direct and indirect effects of fires (upper portion, solid red outline) and ground-based post-fire salvage logging (lower portion, dashed black outline) on soils and hydrologic processes that lead to increased runoff, erosion, and sediment delivery. Not all changes are represented and some of the effects interact with others. Adapted from Wagenbrenner et al. (2015).

downstream sediment delivery by surface runoff (**Figure 1**), or as debris flows given specific geologic and precipitation conditions (Kean et al., 2011). Soil erosion by surface runoff can be many times greater after wildfire than the soil erosion rates in undisturbed forests (Moody & Martin, 2009), and post-fire debris flows can scour upland channels and deliver thousands of tons of sediment to valley bottoms (Kean et al., 2011).

Post-fire runoff and erosional responses are strongly dependent upon the degree of soil damage caused by the fire (represented by “direct effects” in **Figure 1**). The magnitude of the potential changes is affected by the amount of heat released by the fire and imparted on the vegetation and soils (fire intensity) (Keeley, 2009), and the effects are normally categorized into a four-level soil burn severity classification system (Keeley,

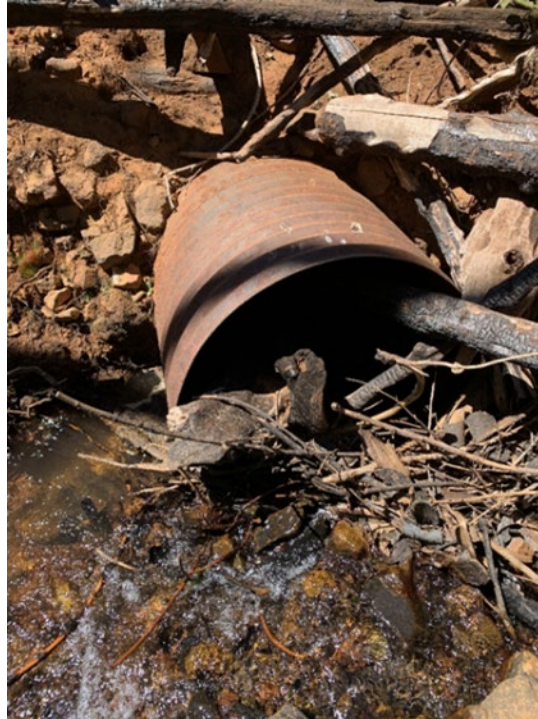
Figure 4. A culvert partially blocked by burned wood and debris in the 2020 North Complex Fire in Butte County, California. In this picture, the road is acting as a partial barrier and a sink for runoff, sediment, and debris.

- Roads can be barriers to flowpaths. An example of this may be an elevated road prism on gentle terrain, where the road acts as an embankment that blocks a potential flowpath. Drainage structures (e.g., culverts) at watercourse crossings can often become barriers when excess debris and sediment plugs the structure (**Figure 4**).
